COMPANY NAME

HEALTH & SAFETY RISK ASSESSMENT

Risk Assessment Details

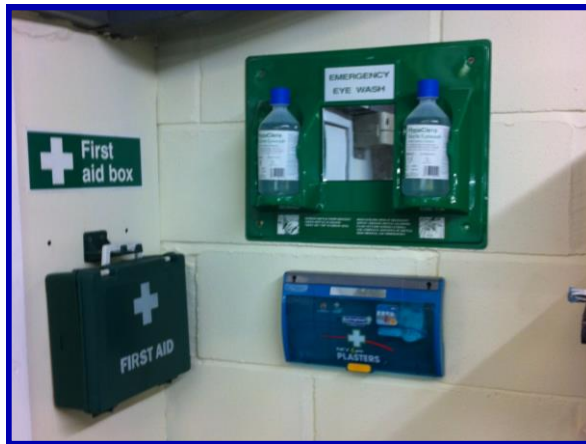
Suitable first aid facilities are provided

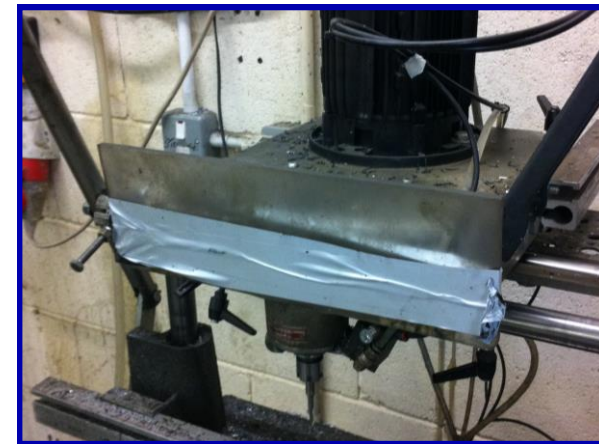
Machine guarding **MUST** be used

At the time of the consultant's visit some machinery was being used without the protective guarding's in place. The risk assessments have been reviewed for 2016 so employees should re-read the machinery risk assessments and safe systems of work so they understand how and why to employ the guarding, furthermore the correct use of machines should be enforced.

<p>Workplace Machinery</p>	<p>At the time of the consultant's visit the guard on AV105 Operating Router had been taped open and the blade guard on the mitre saw was not pulled down fully to cover blade whilst in use. Ensure that dangerous parts of machinery are suitably guarded and ensure employee re-read and understand the machinery risk assessments.</p>	<p>Intolerable</p>

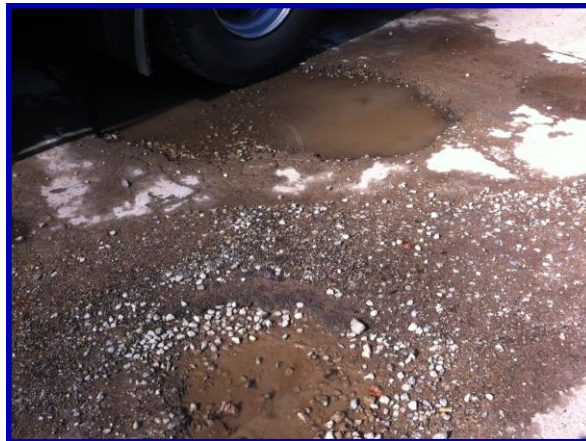
Pot holes in the delivery area must be repaired

RISK ASSESSMENT	ACTIONS REQUIRED	RISK LEVEL	TARGET DATE	DATE COMPLETED	SIGNED
Car Park	As previously highlighted - The road that surrounds the building is in need for some improvements with regards to the condition of the road surface and pot holes. There are some large pot holes forming which should be filled in to prevent any foreseeable accidents with people walking or operating the FLT / vehicles within the area. Arrangements should be implemented to routinely maintain road surfaces.	Moderate			
Manual Handling	On going - Implement safe systems of work regarding hazardous manual handling operations. It was previously discussed that a booklet can be created which can then be used as a training aid for employees.	Moderate			
Pedestrian Routes	In general the walkways are free from obstructions and hazards. A drain cover should be placed over the drain outside the rear fire exit of workshop 1 and the drain at the rear exit from workshop 2 should be unblocked to remove the standing water and leaves. Ensure pedestrian routes are kept free from obstructions or trip/ slip/ fall hazards.	Moderate

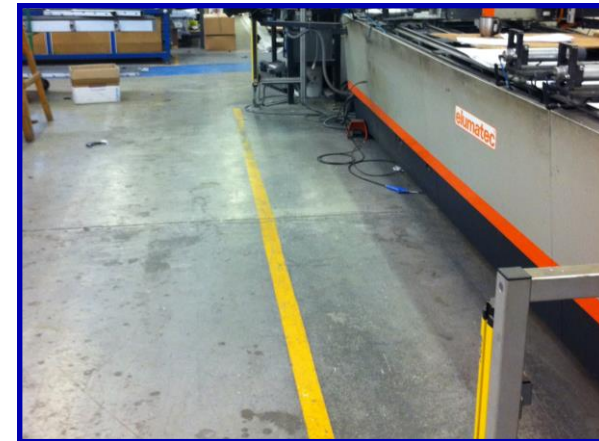
Sufficient safety devices are in place for high risk machines
